**PRELIMINARY ASSESSMENT/  
VISUAL SITE INSPECTION**

**PETERSON BUILDERS, INC.  
STURGEON BAY, WISCONSIN  
WID 096 828 975**

**FINAL REPORT**

Work Assignment No.	:	C05087
EPA Region	:	5
Site No.	:	WID 096 828 975
Date Prepared	:	February 5, 1993
Contract No.	:	68-W9-0006
PRC No.	:	009-C05087WI2H
Prepared by	:	PRC Environmental Management, Inc. (Kurt Whitman)
Contractor Project Manager	:	Shin Ahn
Telephone No.	:	(312) 856-8700
EPA Work Assignment Manager	:	Kevin Pierard
Telephone No.	:	(312) 886-4448

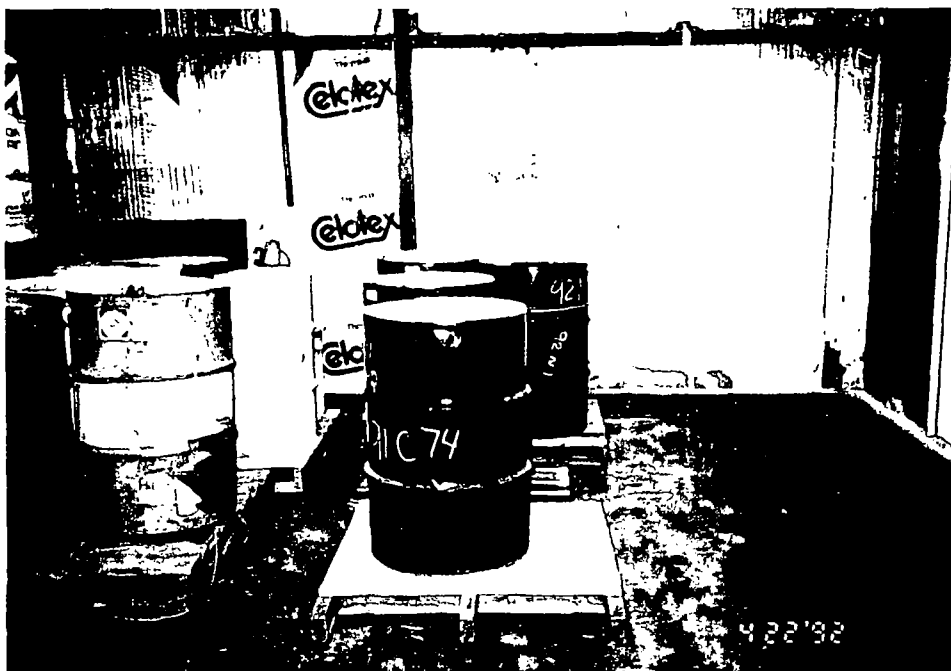
Photograph No. 2

During the VSI, the unit contained flammable raw materials used in manufacturing operations as well as one drum of spent methylene chloride (F002), one drum of circuit board cleaner (D002, D007 and D008), one drum of nonhazardous epoxy washwater, and two drums of nonhazardous water based cutting oil. There are no visible cracks in the concrete. This unit appears to have sound containment. No evidence of release was noted.

Description: This is a photograph of the drums stored in the HWSA (SWMU 1).

**Recommendations:**                      PRC recommends no further action at this time.

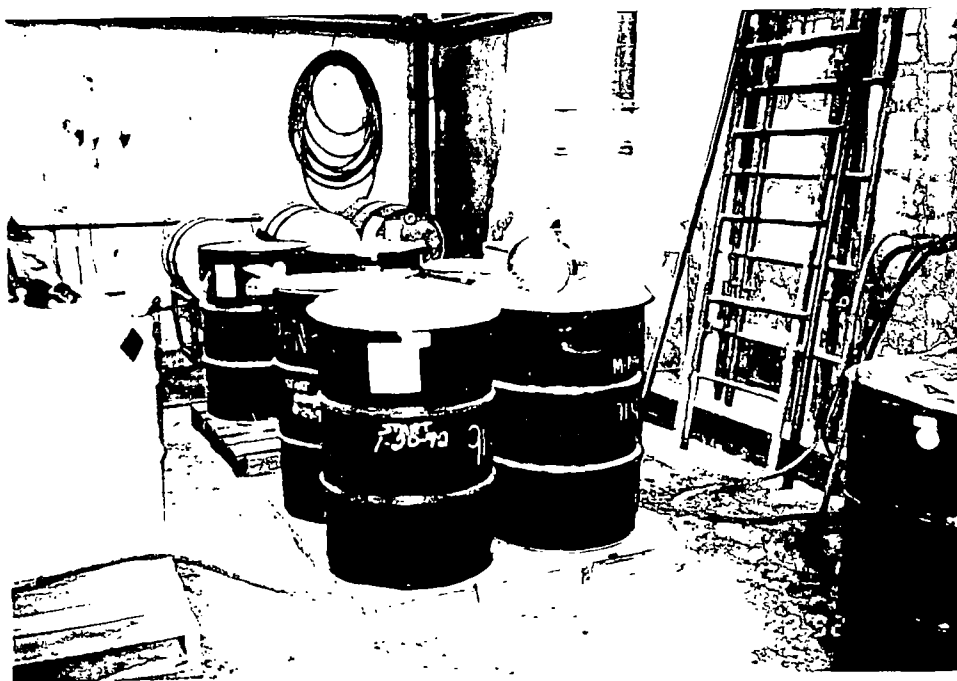
Photograph No. 5  
Orientation: North

During the VSI, the unit contained one drum of spent methylene chloride (F002), one drum of nonhazardous DBE of dimethyl glutonate, dimethyl additate, and dimethyl succinate, one drum of dioctyl phthalate (U028) and one drum of M-Pyrol. None of the drummed wastes were full. PRC observed no cracks in the concrete and no evidence of release. (see Photograph No. 5).

Description: This is a photograph of the satellite accumulation area in Building No. 85.

PRC recommends no further action for this SWMU at this time.

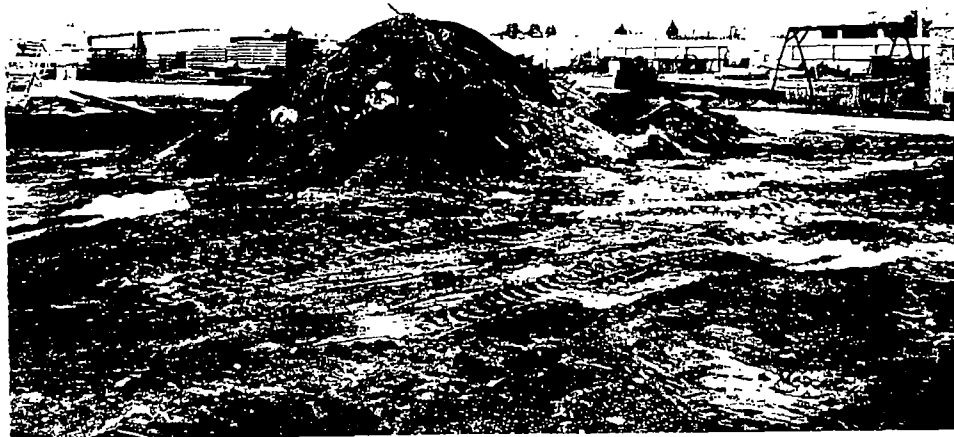
Photograph No. 6

**Unit Description:** The WAP is located outdoors, above ground, and north of Building Nos. 82, 83, and 85. This unit was used to burn wood and wood pallets. The unit measures about 8 feet by 12 feet. The unit is made of burned wood and ashes on a gravel parking lot. The parking lot is level and drainage is minimal (see Photograph No. 6).

**Conclusions:**                      The unit has a low potential for release to ground water, surface water, air, and on-site soils because the WAP is not RCRA-regulated and is not known to contain hazardous constituents or hazardous wastes.

Description: This is a photograph of the wood ash pile.

**Recommendations:**                      PRC recommends no further action at this time.
